Network Transformer Primary Bushing Research – Field and Lab Testing

T. Campbell, I. Roumeliotis, V. Patel, & <u>Y. Wen</u>, Con Edison A. Bologna, N. Hampton, J. Litten, <u>J. Perkel</u>, & J. Potvin, EPRI J. Groeger, Mantis Associates, Inc.

Spring 2025 ICC Meeting, Subcommittee B, May 19, 2025 – Louisville, KY

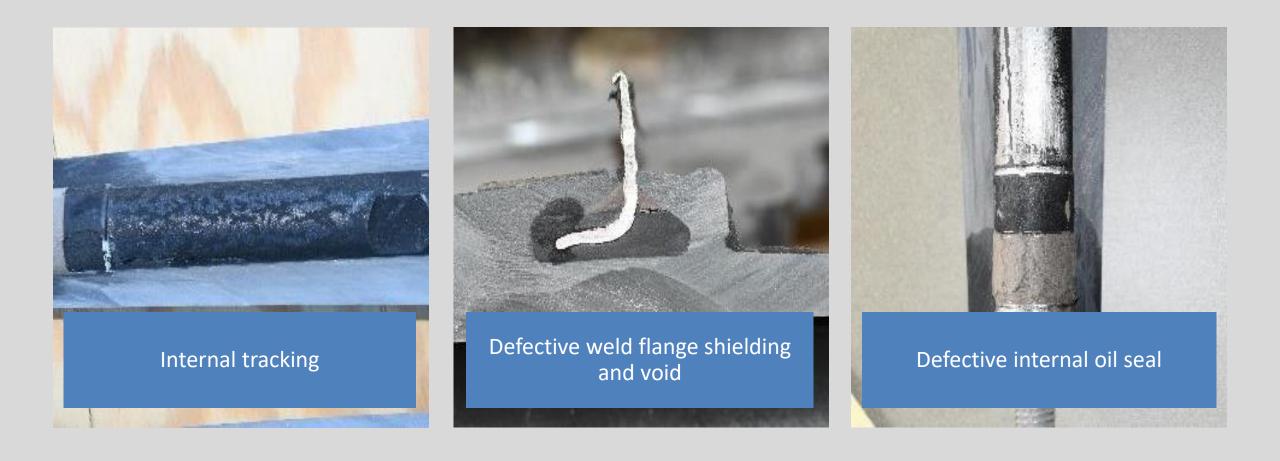
Quality defects that can lead to failure

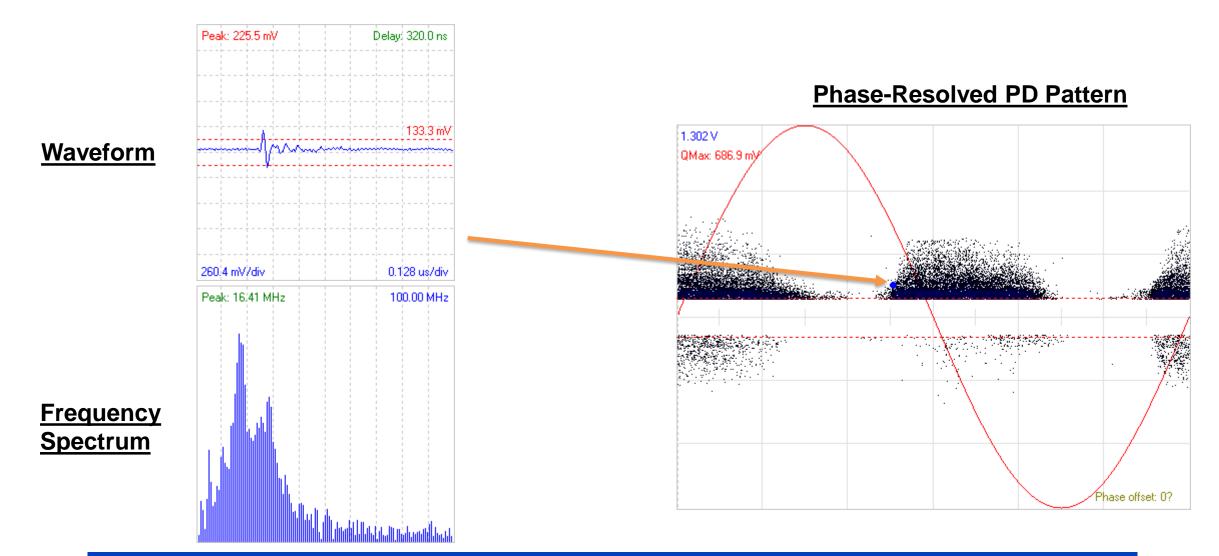
Example Loc 3 Phase C – Closer Look

Smaller pulse height compared to other pulses but includes high frequency components

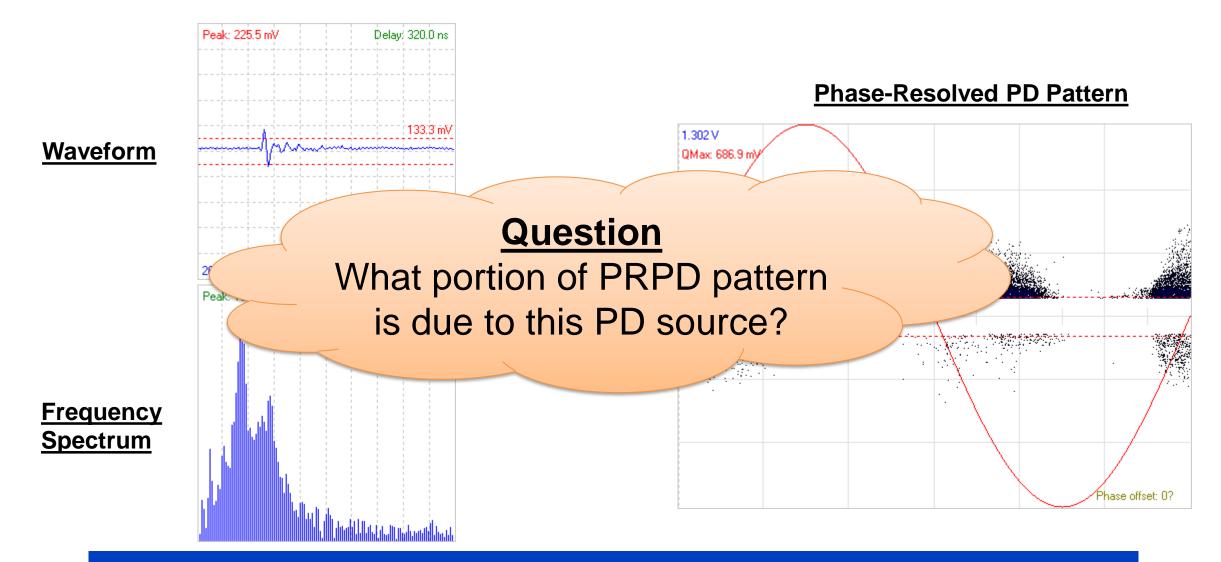
Example Loc 3 Phase C – Closer Look

Smaller pulse height compared to other pulses but includes high frequency components

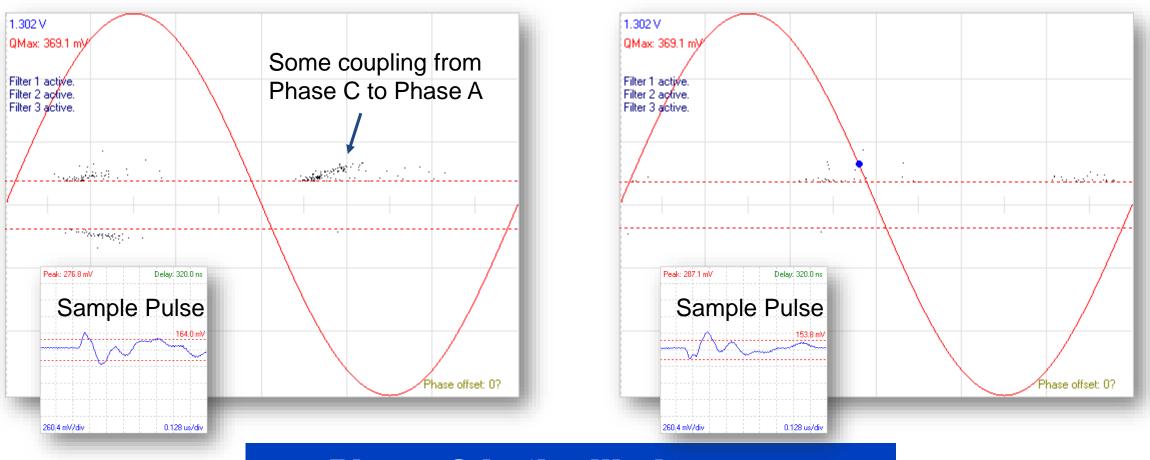
Phase Localization - Apply Filters to Phases A & B

Phase C is the likely source
